# Raccoon Creek Watershed - Lake Milton

Project Status: Complete: 9/5/2006 ODNR Project Number: Jk-MI-113

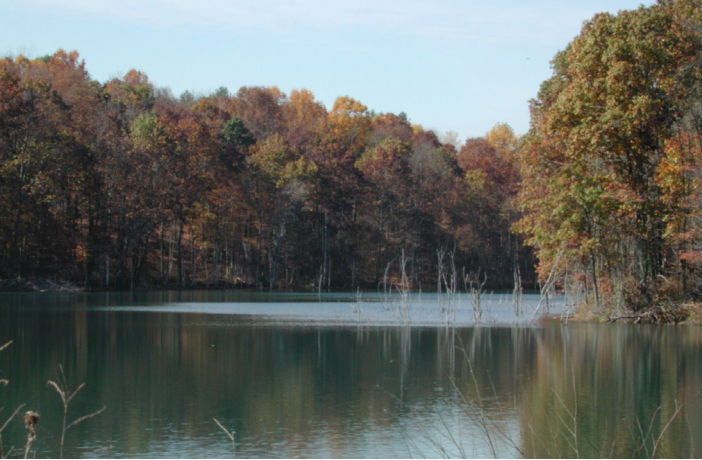
Lake Milton - 25 acre acidic lake, Photo by Ben McCament

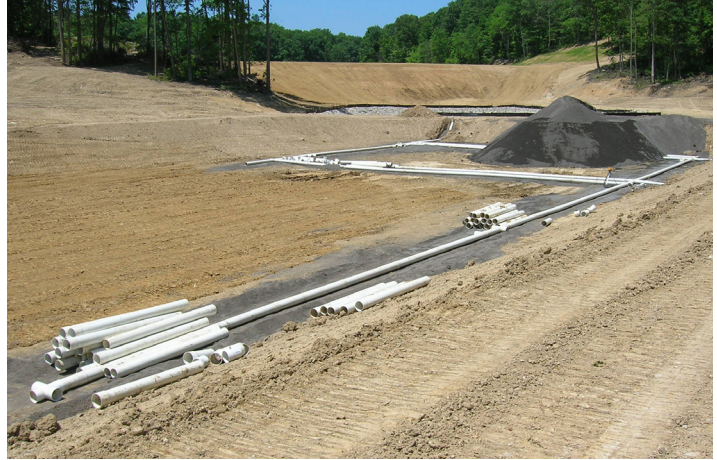
Steel slag bed downstream Lake Milton, Photo by Ian Hughes
