Raccoon Creek Watershed - Pierce Run

Project Status: completed 12/5/12 ODNR Project Number: VN-Vn-06 and VN-Vn-07

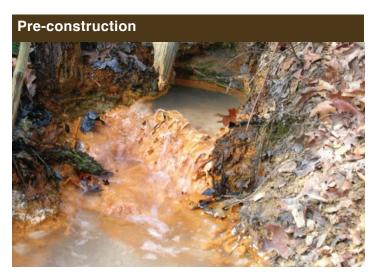
Oreton Seep, the major acid mine drainage discharge Photo by Ben McCament

Pierce Run Reclamation Project is located in Section 19 of Vinton Township in Vinton County and lies within the 12 digit HUC unit #050901010501. The Oreton Seep is located in the former town of Oreton along SR 160 in Vinton County and is the most consistent and largest acid loader within the Pierce Run watershed. The source of the seep is a 116 acre underground coal mine (Clarion 4a seam) which was abandoned by the Oreton Mining Company in October of 1924. The seep appears to originate from a collapsed abandoned entry in an upper valley of a small unnamed tributary. The design was completed by ATC Associates Inc. and ODNR-DMRM for a cost of \$225,815. The treatment approach for this site is to install one large steel slag leach bed. The goal of the design is to reduce acid at the mouth of the Pierce Run (PR0010) before entering into Raccoon Creek. Initial construction was complete Fall 2010 by Seals Construction for a cost of \$587,754. Funding source for the project design was Ohio EPA 319 grant and for construction the sources were ODNR-DMRM, Ohio EPA 319, and OSM. However, modifications to the dam and pipes were needed. In 2011, ODNR completed the design for the slurry wall that will prevent water from seeping around and under the dam. This design also included improvements to the primary outlet (standpipes) that failed after initial construction in Fall 2010. In 2012, King Environmental Group was awarded \$442,395 (substantial cost) to complete the construction of the secondary improvements. Project was complete 12/45/12. Mainstem Pierce Run downstream of acid mine drainage sources show acid and metal loadings at site PR0010 to be 16 lbs/day and 274 lbs/day (figure 1).

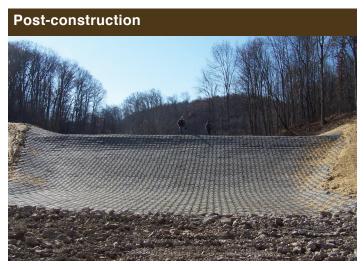
Freshwater pond overflow at Pierce Run Photo by Raccoon Creek Partnership

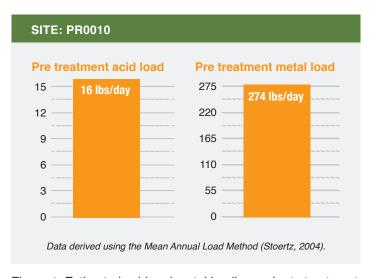
Figure 1. Estimated acid and metal loadings prior to treatment
