Raccoon Creek Watershed - Lake Morrow

Project Status: completed 9/8/2014 ODNR Project Number: JK-ML-62

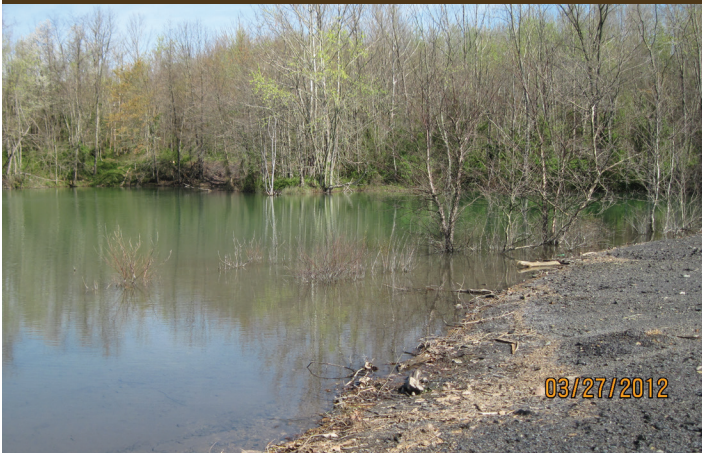
Pre-construction

Lake Morrow pre-construction
Photo by Sarah Landers

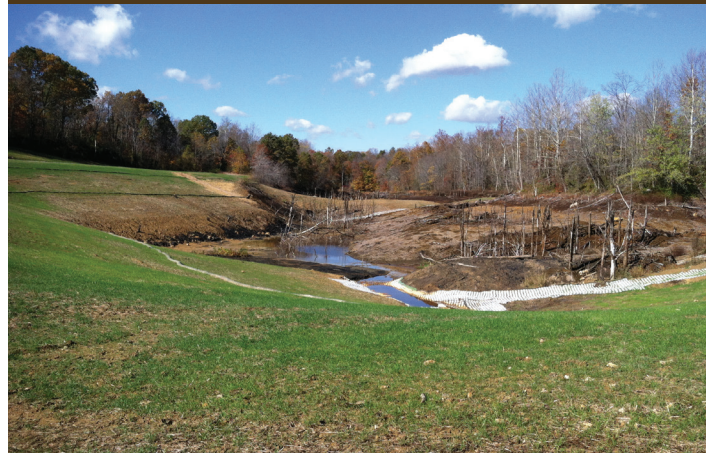
Post-construction

Lake Morrow post construction
Photo by Sarah Landers
