# Raccoon Creek Watershed - Salem Road/Middleton Run

Project Status: Complete: 2005 ODNR Project Number: JK-MI-51

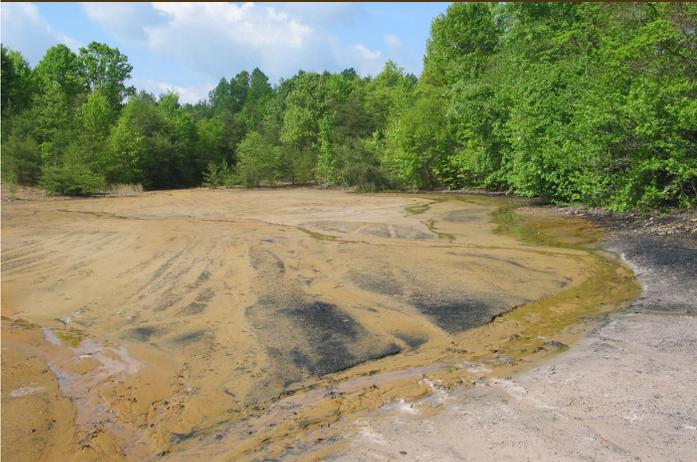
Exposed mine pit floor, Photo by Brett Laverty

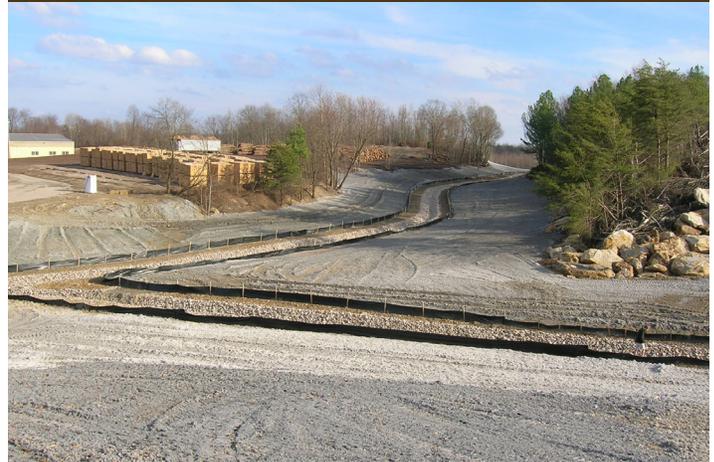
Middleton Run limestone channels, Photo by Ian Hughes

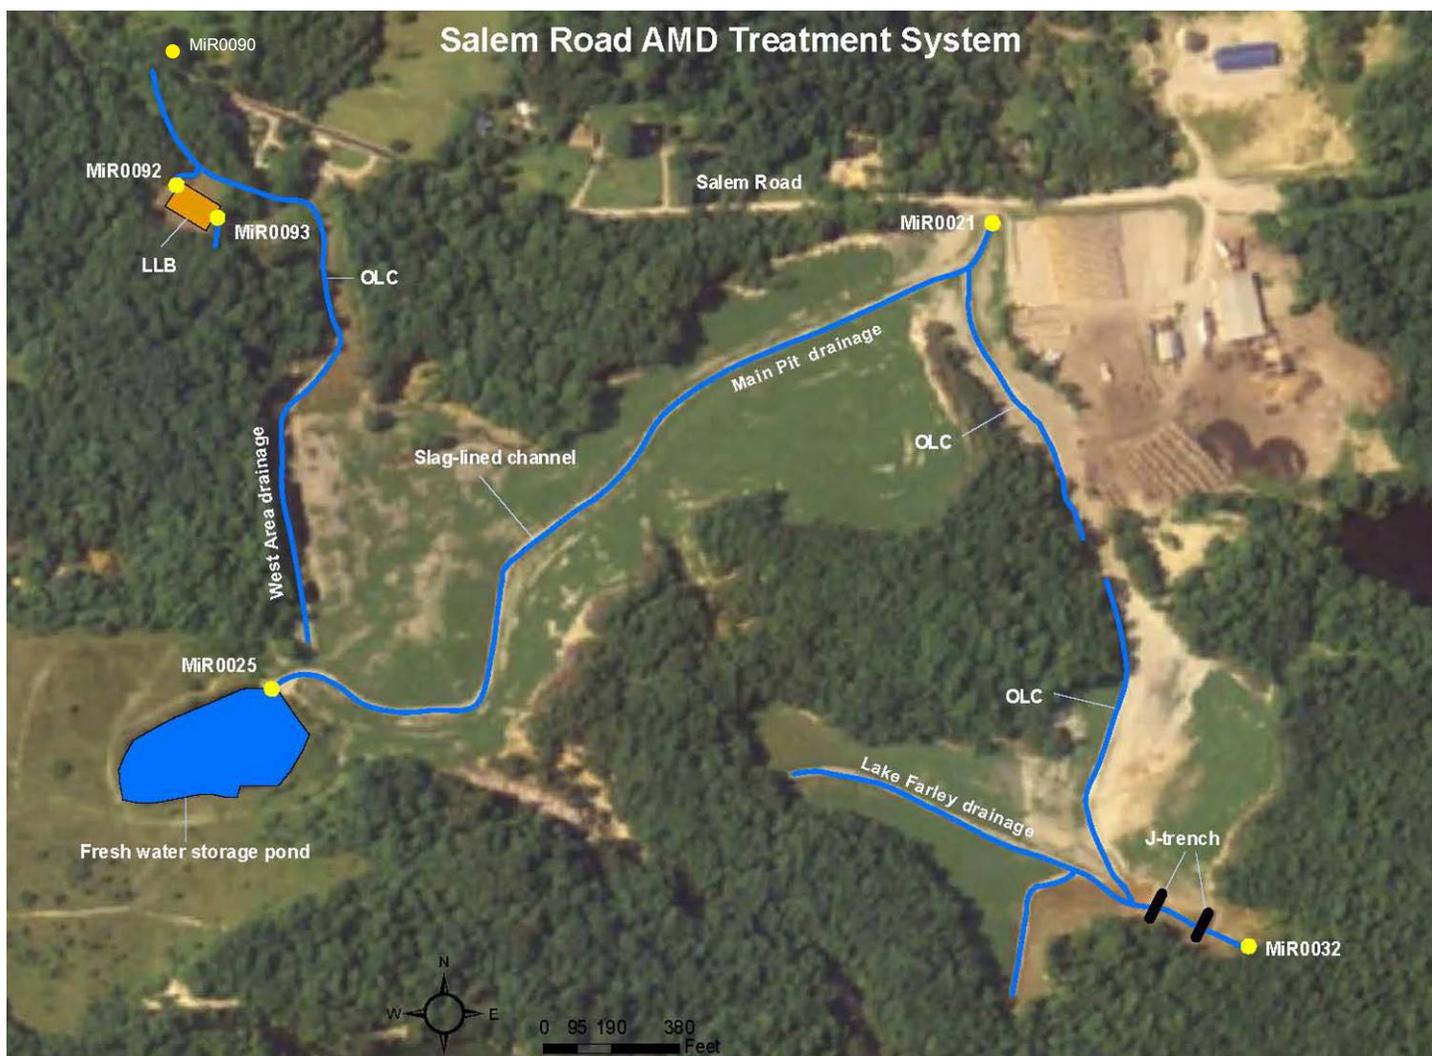
Figure 2. Map of Salem Road AMD treatment system and sites

Sample site ID	Description of the sampling station
MiR0090	Tributary draining limestone leach bed treatment, site is at crossing with Salem Road.
MiR0032	Sample site located directly below the dam at MiR0031. Two limestone J-trenches with steel slag cores (experimental). Reclamation of mine spoil and removal of acidic strip pit.
MiR0021	The site represents discharge across the former mine pit floor that was reclaimed. Sample site is at the Salem Road culvert (fresh water pond draining into a limestone and steel slag channel).
