State Route (SR) 124 Seeps Project is located in Section 15 of Milton Township in Jackson County and lies within the 14-digit HUC unit #05090101050030. The site is 7 acres and is located in the Little Raccoon Creek subwatershed. The design was completed by ATC Associates Inc. for \$80,000. The treatment approach for this site was to install several open limestone channels and conduct basic reclamation. The major consideration for this design was to establish positive drainage, remove several highwall impoundments, cover toxic materials, establish vegetations, and add alkalinity through the limestone channels. The goal of the design was to remove acidity from entering

### Water quality report

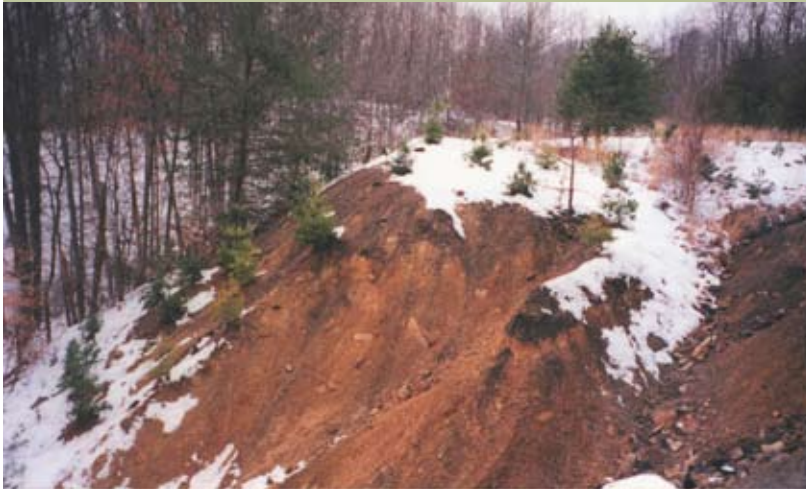
Pre-construction

Between pond and seep  
Photo by Brent Miller

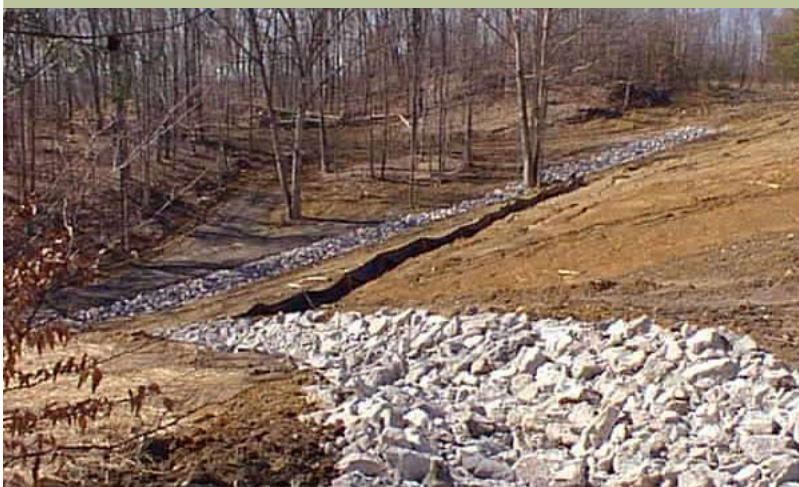
Post-construction

Sr 124 hillside limestone channel  
Photo by Chip Rice

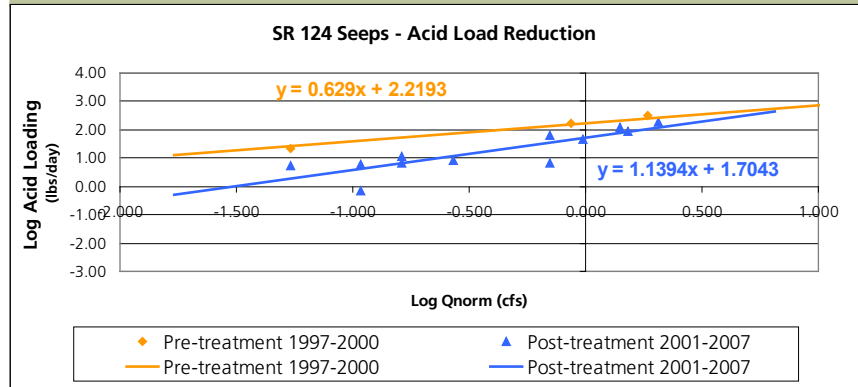
Figure 3. Acid Load Reduction

Using the Mean Annual Load Method (Stoertz, 2004) acid and metal load reduction occurring at this project were plotted and shown in Figure 3 and 4. Acidity, iron, aluminum and discharge were measured pre- and post-construction at the project discharge from 2/1/1997 to 11/27/2000 for pre-construction and from 6/19/2001 to 8/1/2007 for post-construction.
